Improper Concentric Slave Cylinder Consolidation

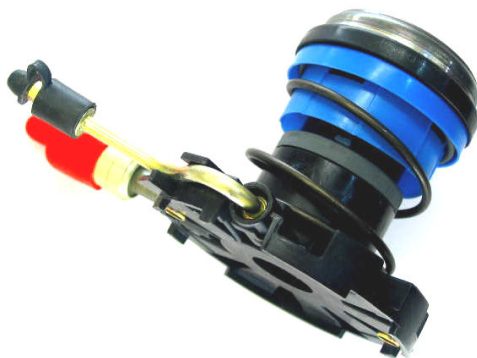
The dust boot is designed to protect the hydraulic seals from abrasive clutch dust and other contaminants. The early-style CSC was prone to premature failure as a result of contamination.

Early-style CSC without dust boot and revised release bearing

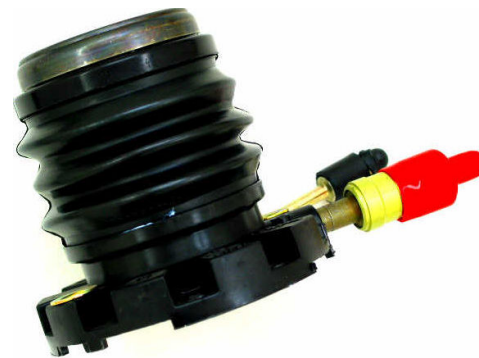
Late-style CSC with dust boot and revised release bearing
